Mechanical Tests and Failure Analysis on Selected Components of the Class 60 Armored Vehicle Launched Bridge (AVLB) During the Class 70 Modification Program

ARL-TR-1269

December 1996

Weapons and Materials Research Directorate, ARL

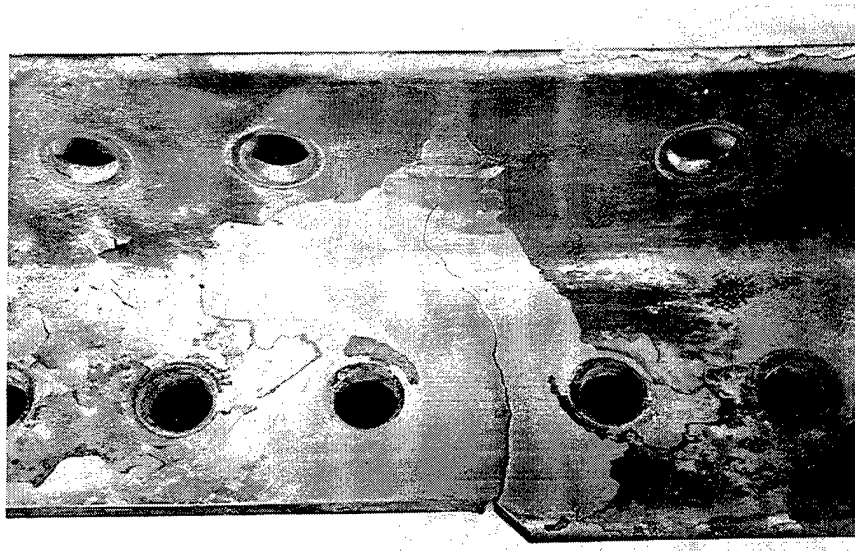
Figure 2. A view of the front side of the cracked inner splice aluminum angle showing the crack, which had initiated at a sharp corner in the angular notch, extending across the horizontal leg and 4/5th of the way up the vertical leg. Note that a portion of the edge was already machined from the leg edge, resulting in an angular notch with a sharp corner that can serve as a stress raiser (stress concentration). Magnification: Approx. 0.4x.

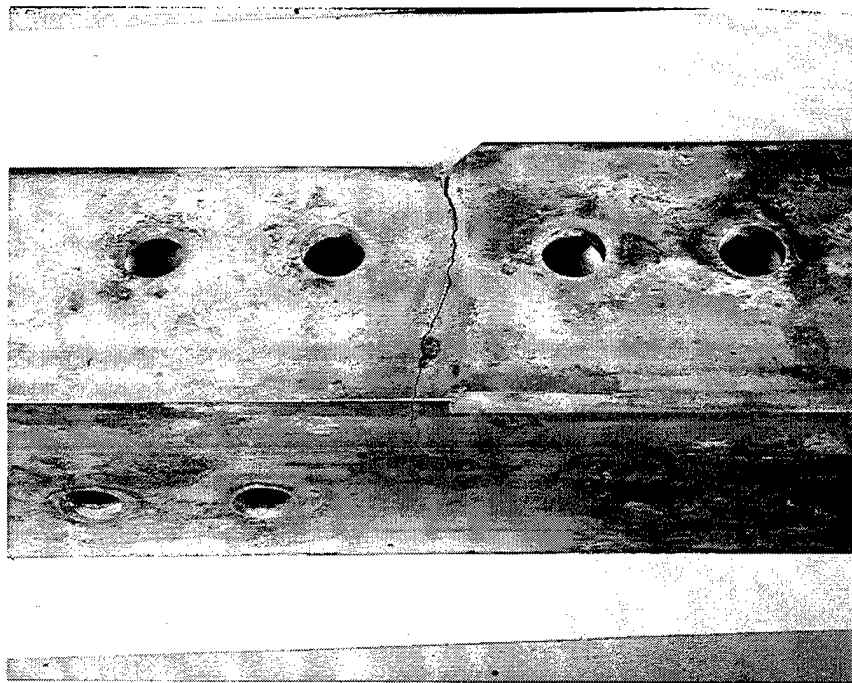
Figure 3. A view of the back side of the same angle in Figure 2. Areas of white corrosion products can be seen on the back sides that were not painted, indicating intrusion of the moisture in the gaps of the spliced joint. Magnification: Approx. 0.4x.

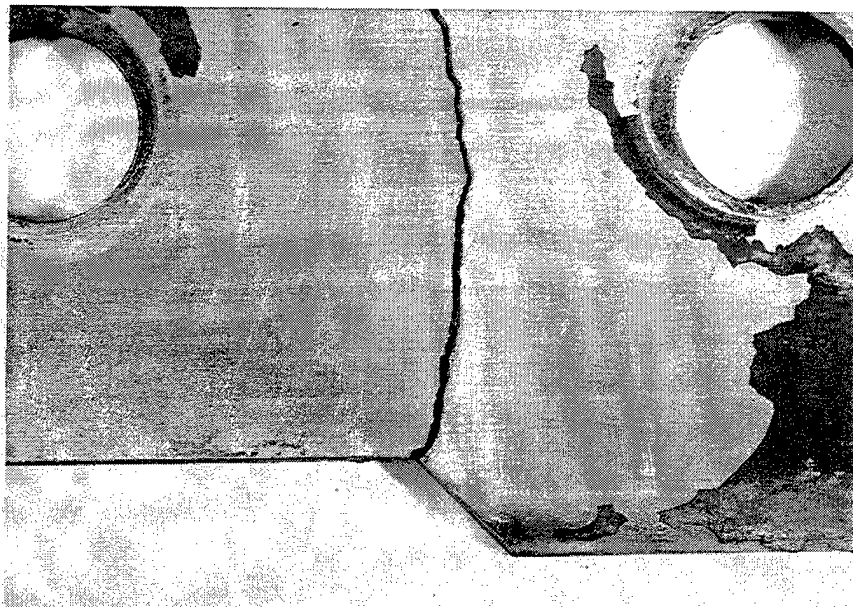
Figure 4. A close-up view of the machined angular notch with a sharp corner that acted as a stress raiser where the crack initiated. Same angle as in Figure 2. Magnification: 1 1/3x.

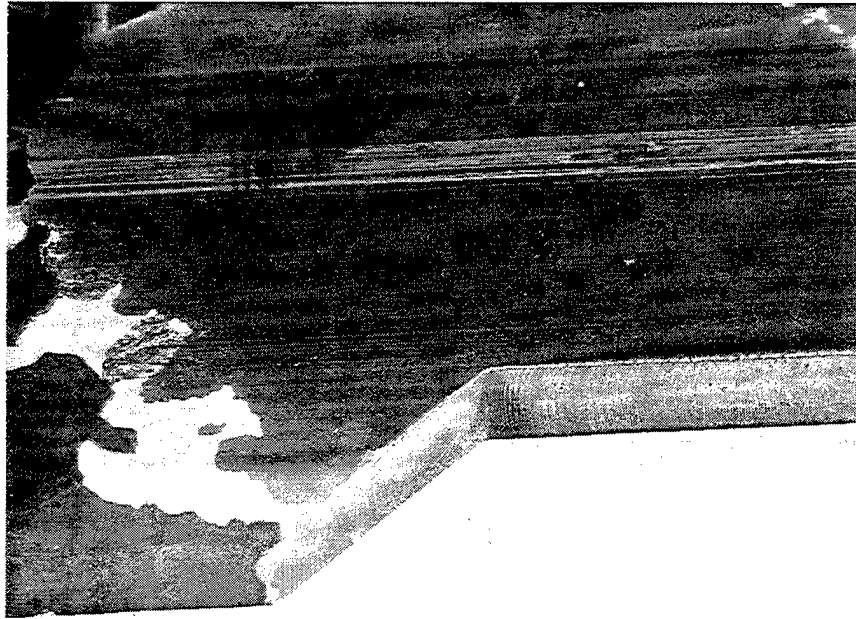
Figure 5. A close-up view of the machined angular notch with a sharp corner in the outer splice angle with no crack. Note the machining of the edge from the angle leg. Magnification: 1 1/3x.

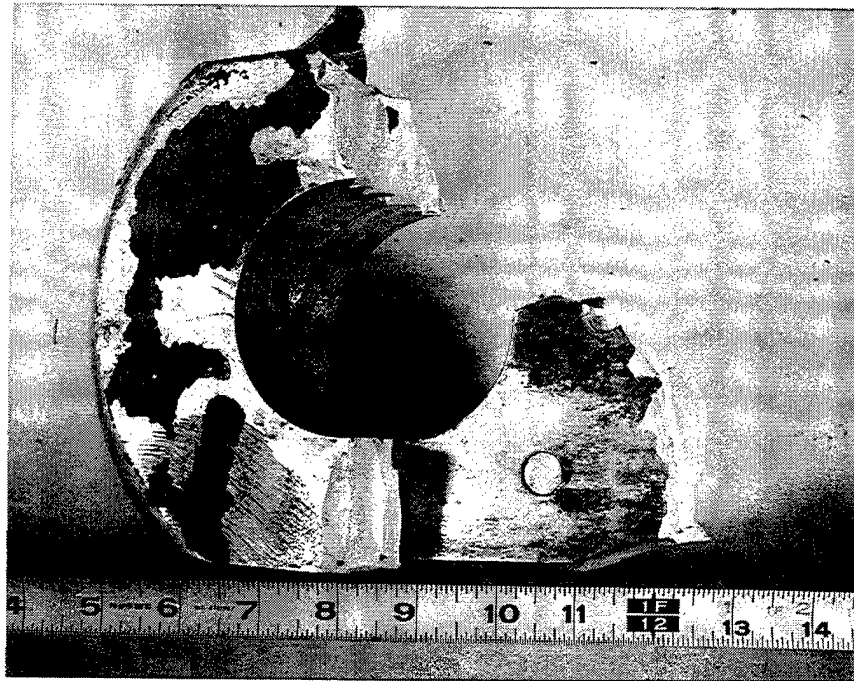
Figure 7. A view of the broken eyehole section from the failed male bottom connector.

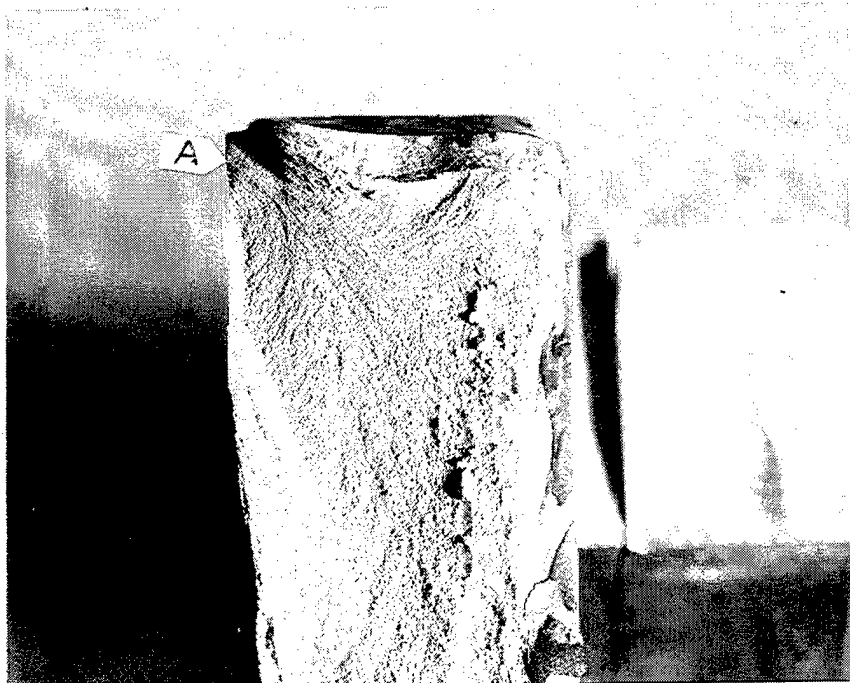
Figure 9. Close-up view of the fracture at location (A) in Figure 8. The features of the fractured surface point toward the failure origin. Magnification: Approx. 1.5 \times .

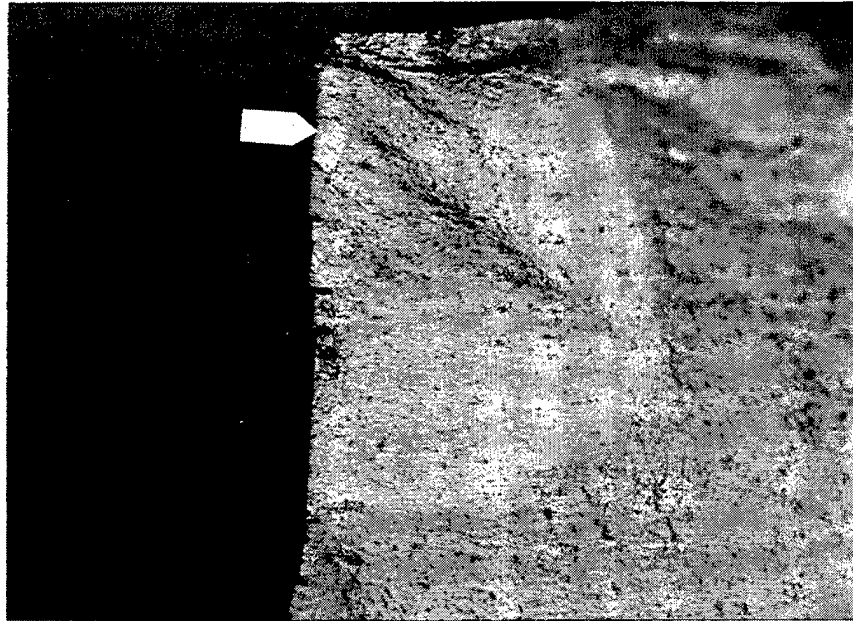
Figure 11. Close-up view of the same area in Figure 10, but at a higher magnification to show smaller fatigue cracks at the edge of the vertical machined sharp notch that cannot be seen in this photograph. Magnification: Approx. 4.3x.

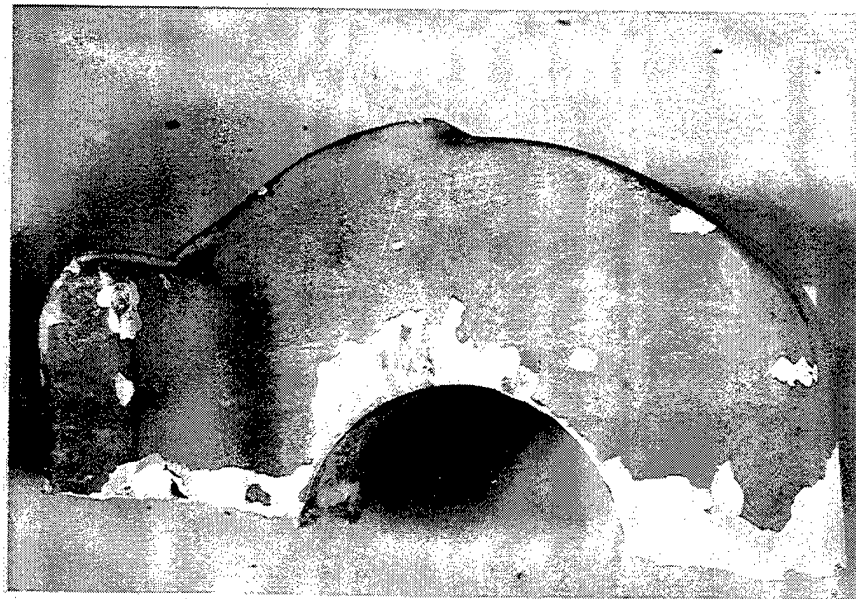
Figure 12. A side view of the broken eyehole section from the failed outboard female bottom connector (outboard forged part). It was removed from a female center panel assembly of the No. 2 Modified AVLB after the bridge's second failure during the fatigue tests. The connector part broke across the 3-in-diameter eyehole for the connector steel pin.

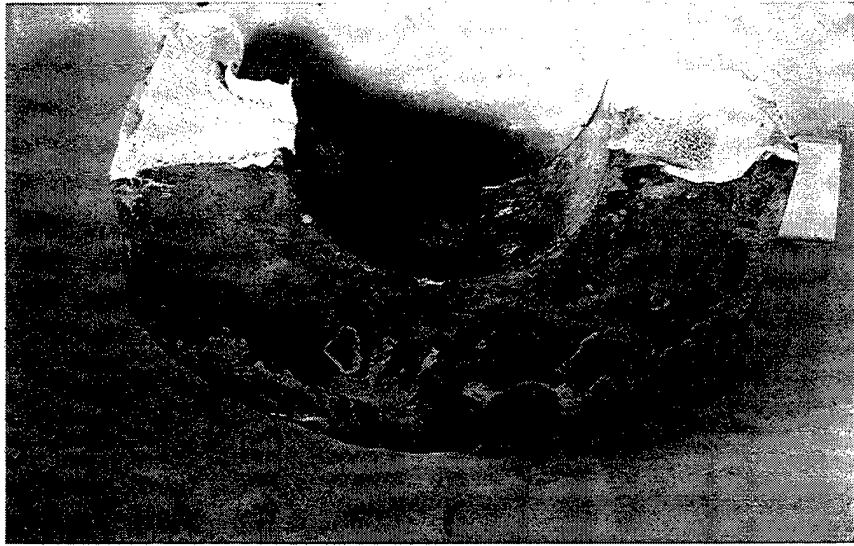
Figure 13. Same broken eyehole section in Figure 12, showing the fractured surfaces.

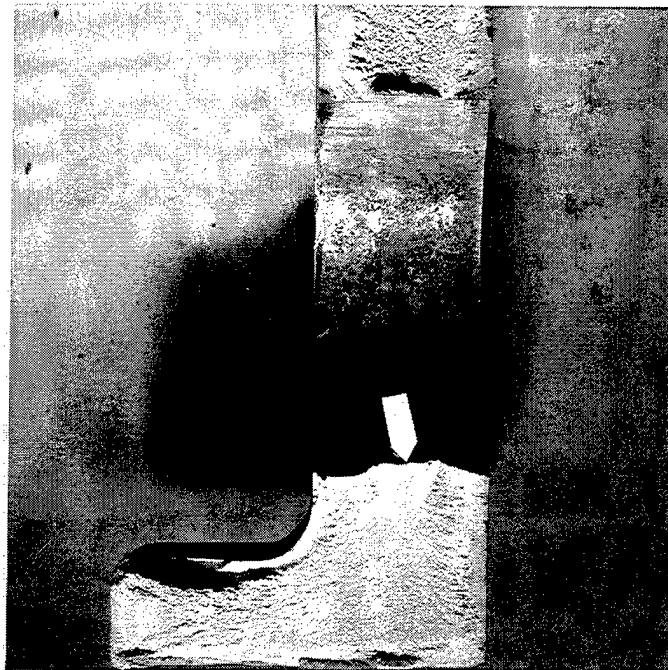
Figure 14. A view of the fractured surfaces of the broken section in Figure 13, showing the location of the failure origin (arrow) at the bottom edge of the 3-in-diameter eyehole. It reveals the characteristic feature of a fatigue crack. Although not clearly seen in the photograph, the corrosion products were observed on the internal bare surface of the eyehole, indicative of corrosion. The eyehole was slightly worn by the steel pin rubbing against it, removing most of the paint to produce bare areas to corrosion.

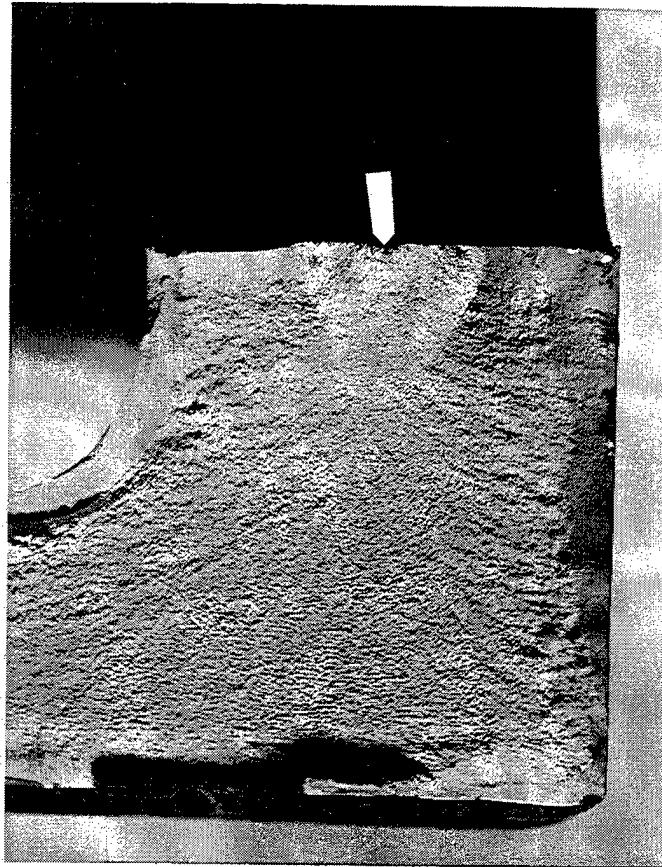
Figure 15. Close-up view of the origin failure (arrow) in Figure 14. Although not clearly seen in the photograph, a small area of discoloration that may be indicative of corrosion was observed in the fatigue crack at the eyehole edge. This was where the fatigue crack had initiated, growing to the critical size during fatigue cyclic loadings to the point of brittle fracture in the forged bottom connector across the eyehole section.

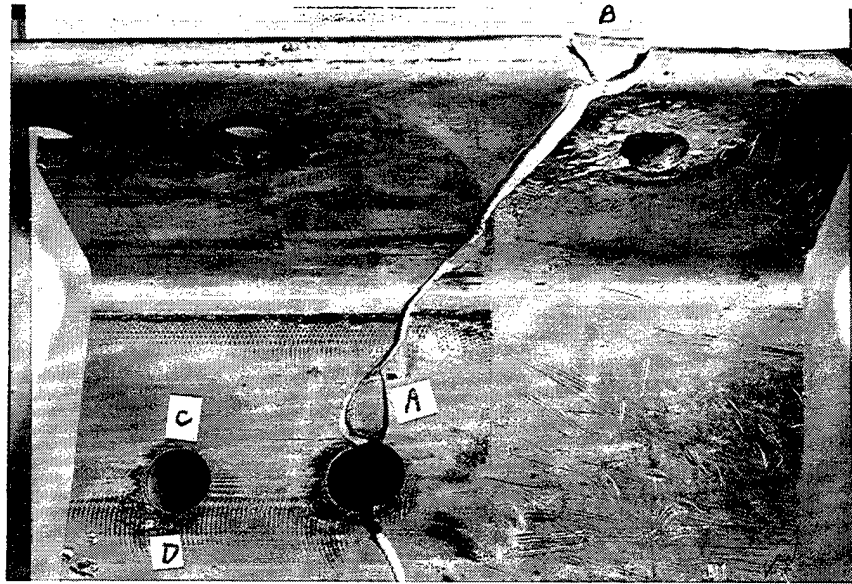
Figure 20. Top view of the broken angle section of the failed bottom chord on the female center panel assembly of the No. 2 Modified AVLB. The crack went across the countersunk rivet hole in the horizontal leg. Note the blackened areas at the edge of the holes in the horizontal leg and along the inside corner of the angle in addition to the outlines of the machined marks from the bottom of the forged center hinge in contact with the top surface of the angle. Two small pieces (A and B) probably broke off during the removal of the broken section. Two small cracks (C and D) were observed 180° apart in the edge of the second rivet hole in the horizontal leg. One-half actual size.

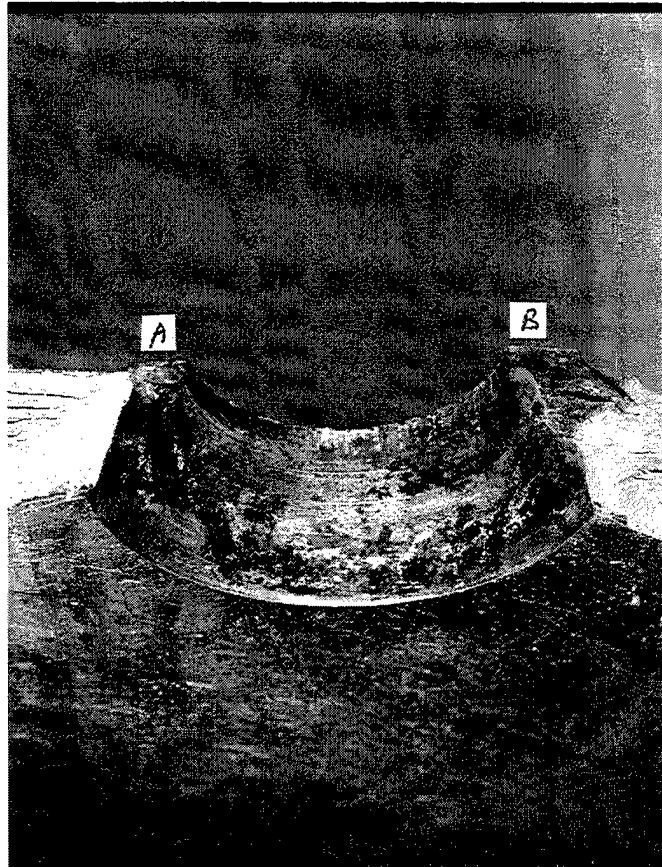
Figure 22. Enlarged view of the fractured countersunk rivet hole in Figure 21, viewing the hole from the bottom surface of the angle. The discolored areas at locations A and B and fatigue beach marks at both corners of the hole were the origin sites of the brittle failure in the bottom chord angle. Magnification: 2.2x.

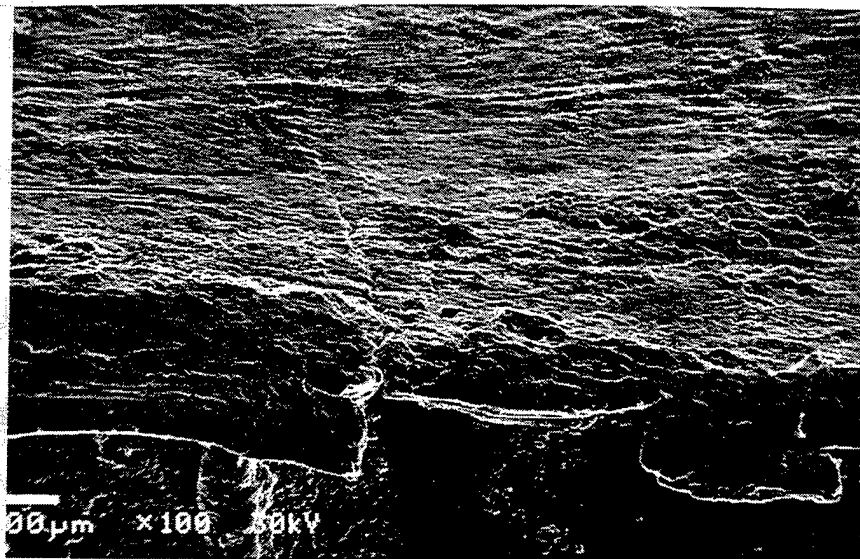
Figure 25. Electron scanning microscope view of the small crack in Figure 24 along the top surface at the hole edge of the small-angle piece. Magnification: 100 \times .

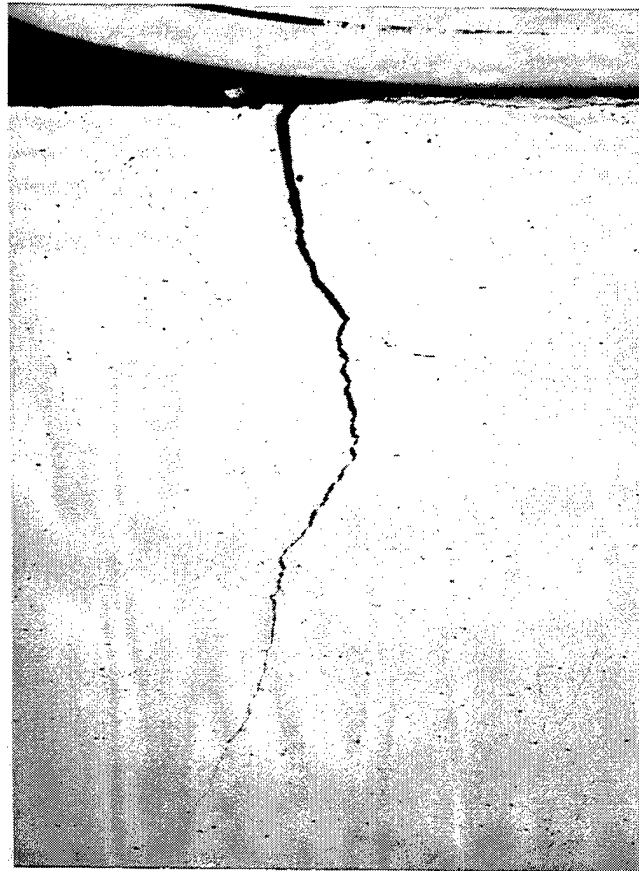
Figure 26. As-polished specimen with the crack seen in the small angle piece in Figure 24. The crack extended from the top surface halfway down the land edge of the countersunk rivet hole. Magnification: 40x.

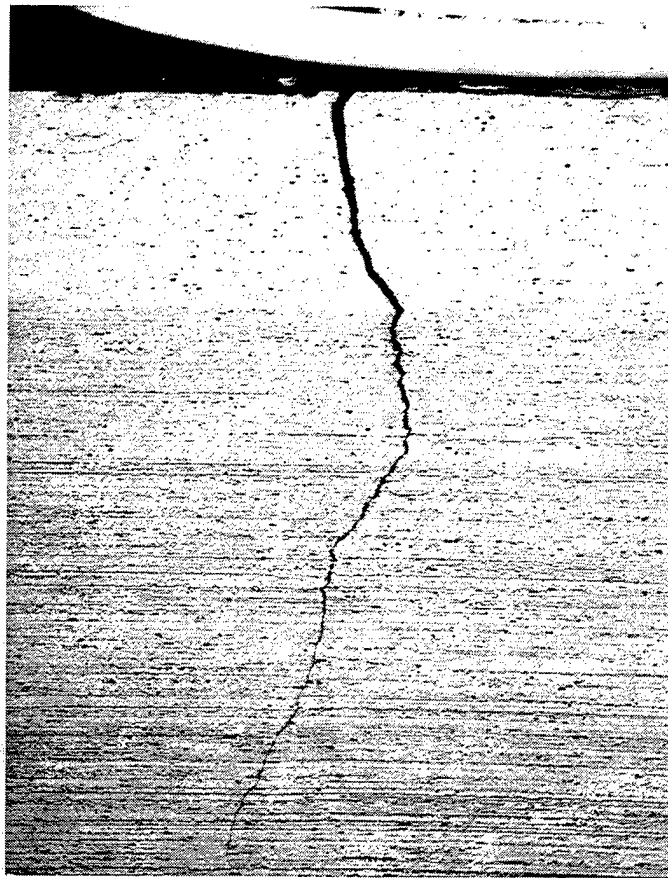
Figure 27. Same area in Figure 26 except etched to reveal the microstructure. The wide light-colored band in the top surface is the recrystallized layer as the result of the angle extrusion process. Magnification: 40 \times . Keller's etchant.

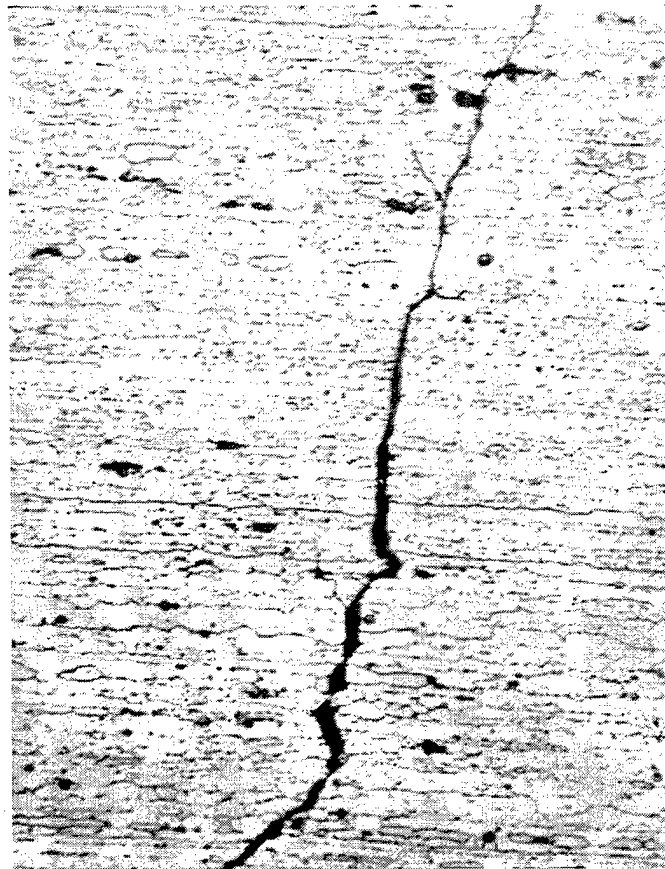
Figure 28. A view of the etched microstructure about 3/4 of the way down the crack in Figure 27. Some branching of the crack is seen. Note that the crack is transgranular since it went across the grains. The grains are elongated as the result of the angle extrusion process. Magnification: 360x.

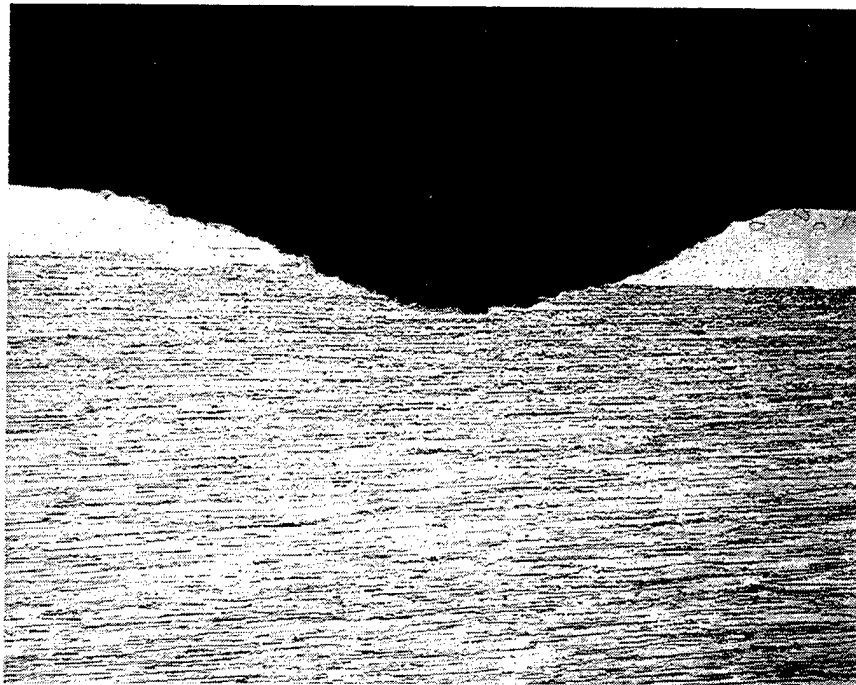
Figure 29. A view of a surface corrosion pit in the top surface of the broken angle. The cross section is through the blackened area in the inside corner of the angle in Figure 20. Magnification: 40x. Keller's etchant.

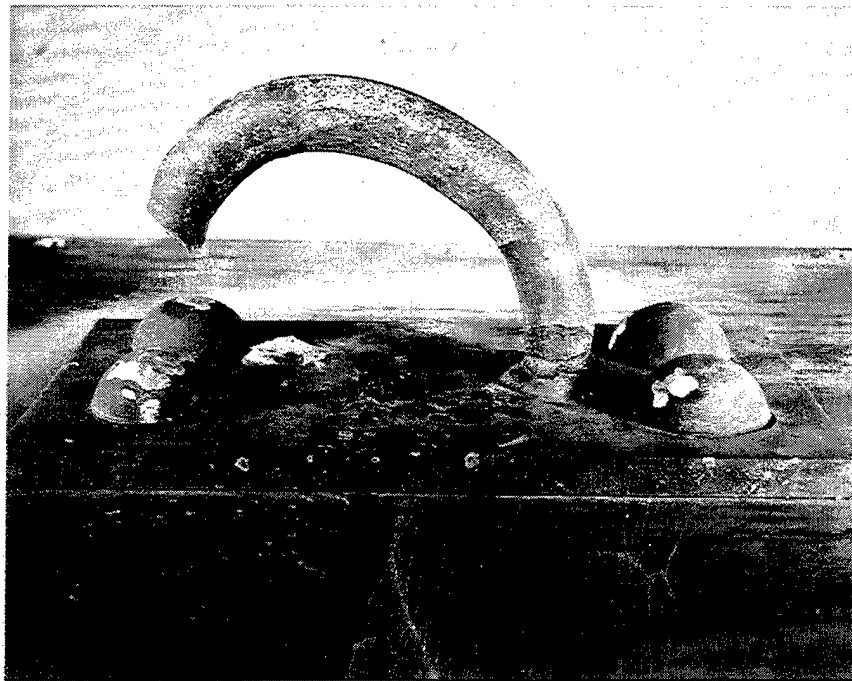
Figure 38. The failure of the AVL B tie-down device after the pull test. The broken end of the steel bar failed under the hook by shearing in the bevel-fillet weld.

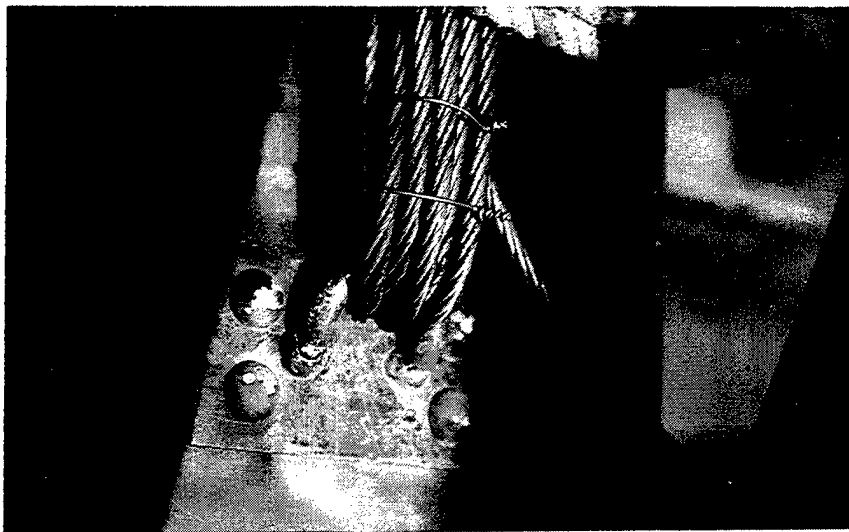
Figure 42. A view of the tie-down device after the pull test to show the mode of the failure of the U-shaped bar by bending and cracking at the welded joints.

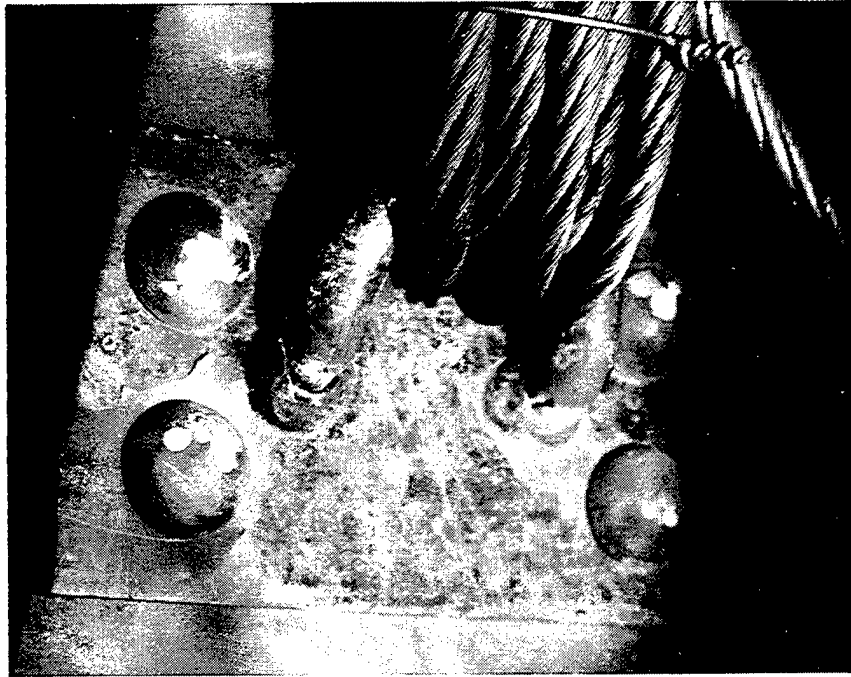
Figure 43. Enlarged view of the failed tie-down device in Figure 42. Note that the failure occurred in the upper toe of both welds.

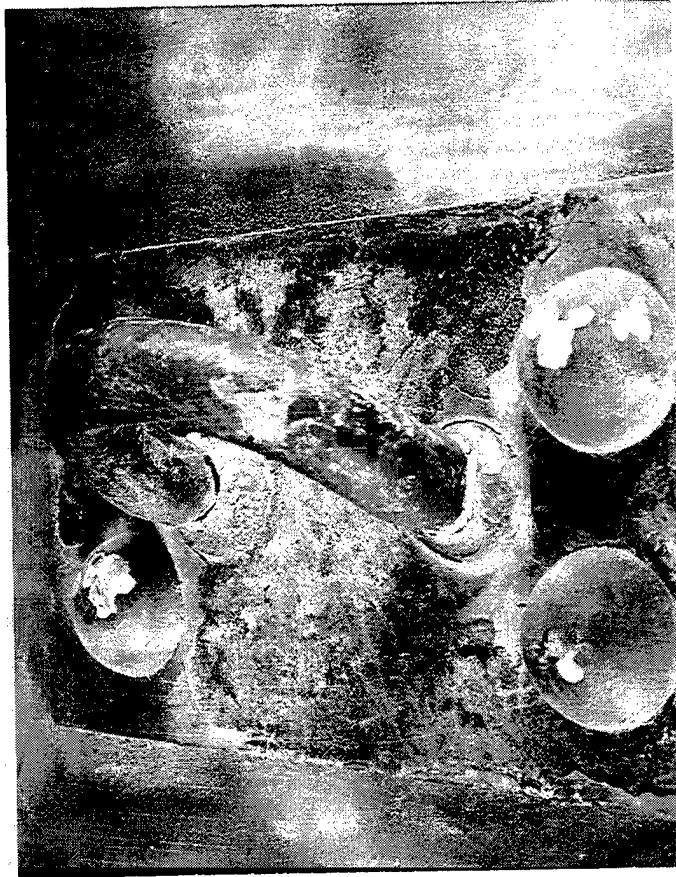
Figure 44. Close-up view of the failed tie-down device in Figure 43 after the removal of the wire rope for a clearer view.

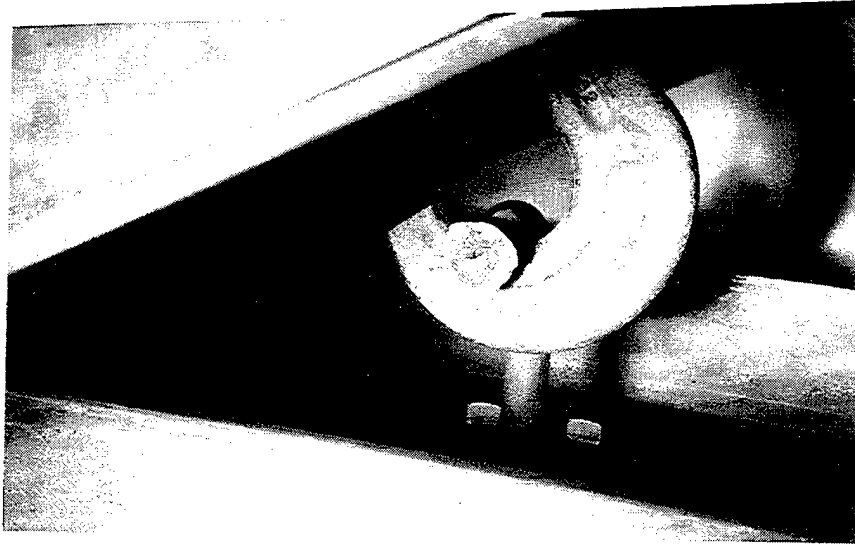
Figure 47. Close-up view of the failed welded end of the U-shaped bar of the third tie-down device tested after the pull test.

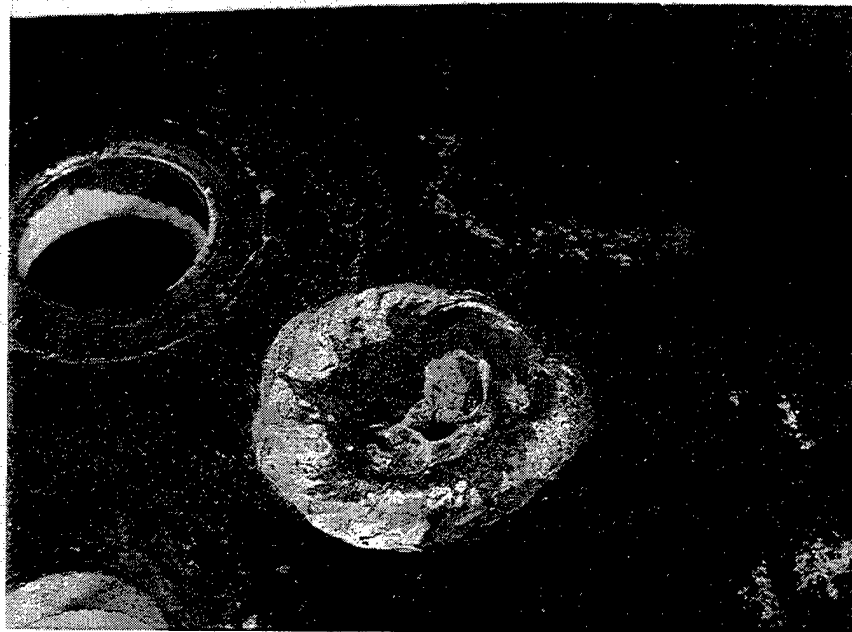
Figure 50. Enlarged view of the weld fracture in the tie-down base plate where the welded end of the bar broke loose.

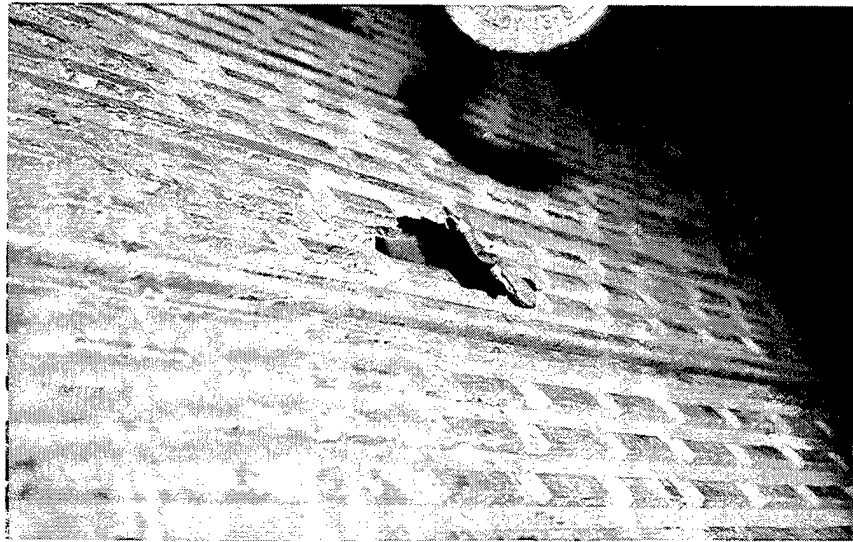
Figure 57. Damage to the oblong hole in the deck panel after the lifting steel bar was pulled out during the first pull test.

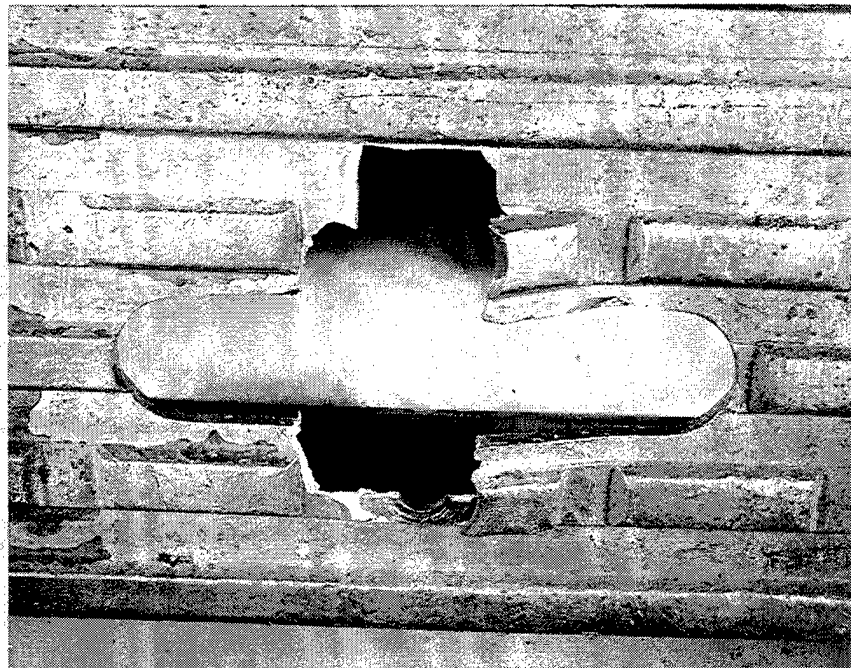
Figure 58. Close-up view of the damaged oblong hole in Figure 57.

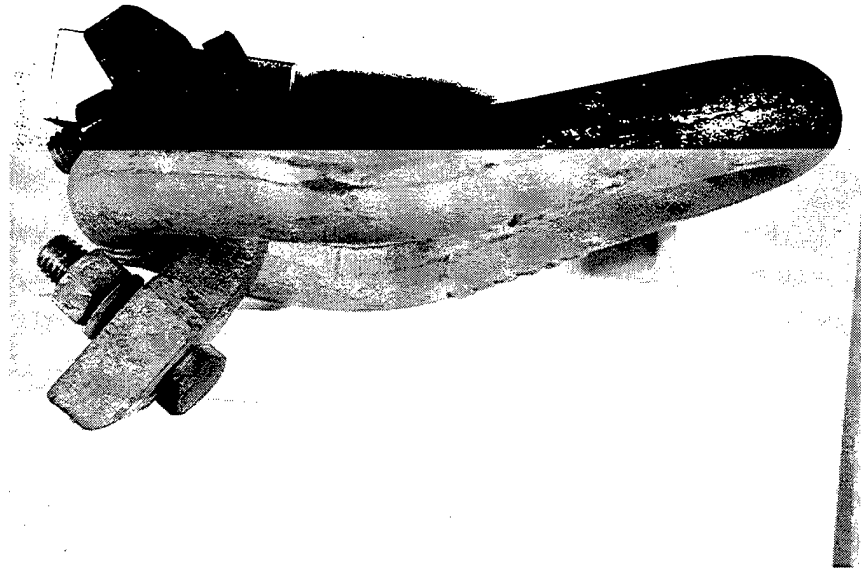
Figure 61. Close-up view of the lifting bar that had bent around the egg-shaped ring during the pull test. Note the 20° offset bend in the ring that had to be bent to be paralleled to the loading axis.

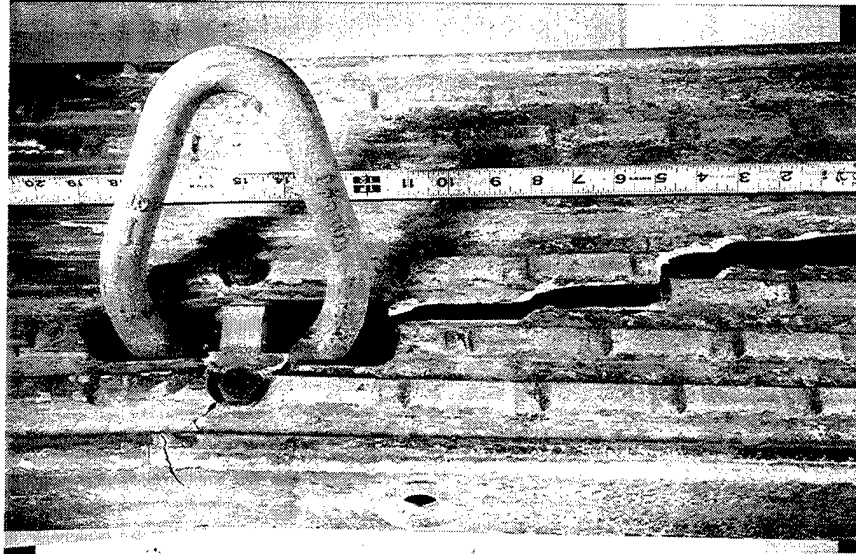
Figure 63. Damages to the extruded aluminum deck panel with the new stronger lifting device bolted to the oblong hole in the panel as the result of the second pull test. Note that the crack started from one end of the oblong hole (right) and continued to the end of the panel (not seen in the photograph). Also, note the smaller cracks at the lower bolt hole of the oblong hole. The bolt hole was sheared and the crack continued to the edge of the panel. The steel ring was used to pull on the lifting bar in the panel during the test.

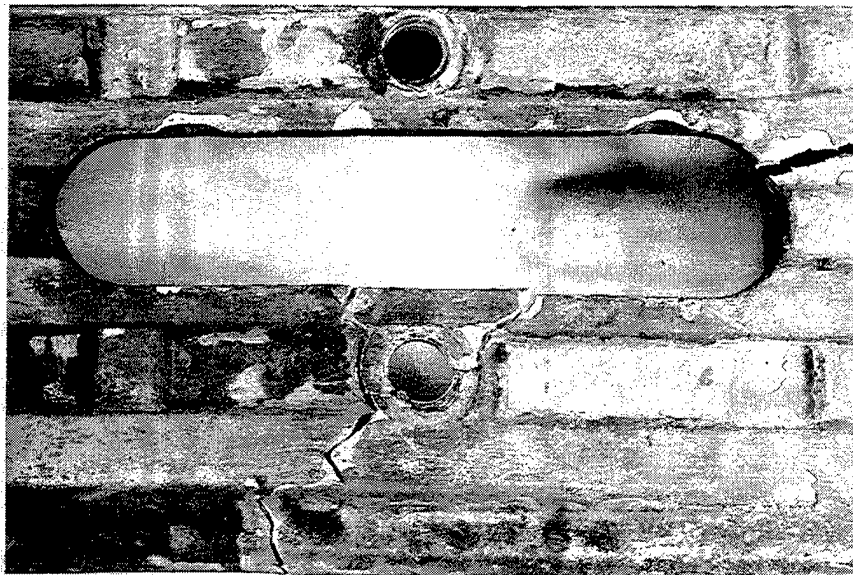
Figure 64. Close-up view of the damaged oblong hole in the deck panel in Figure 63 after the removal of the lifting bar, bolts, and steel ring. Although not clearly seen in the photograph, a small crack was observed in the upper bolt hole.

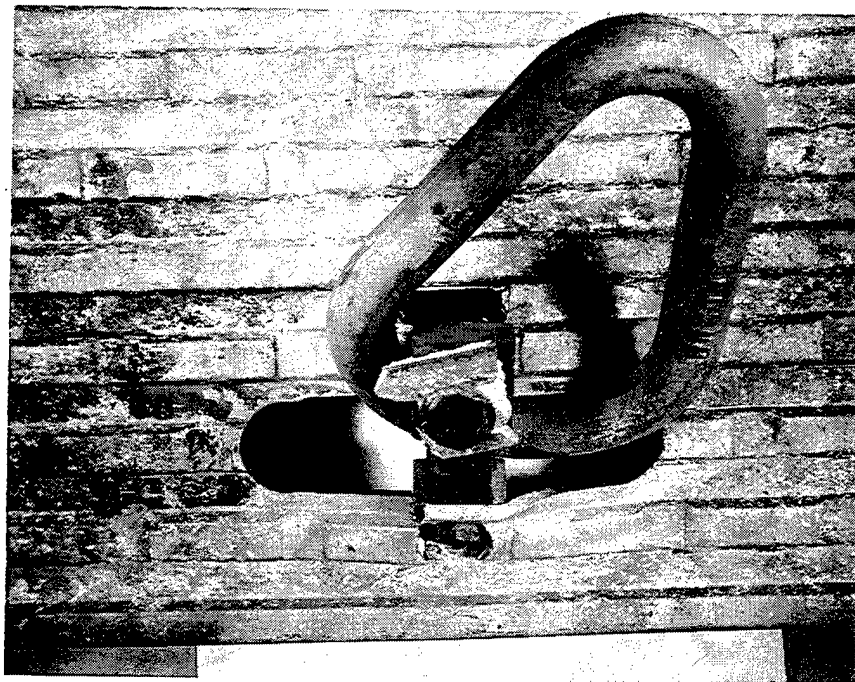
Figure 67. Close-up view of the damaged lifting device at the oblong hole in Figure 66 after removal from the testing machine. Note a small section of the deck panel sheared from the upper edge of the oblong hole, where the final failure of the lifting device occurred.

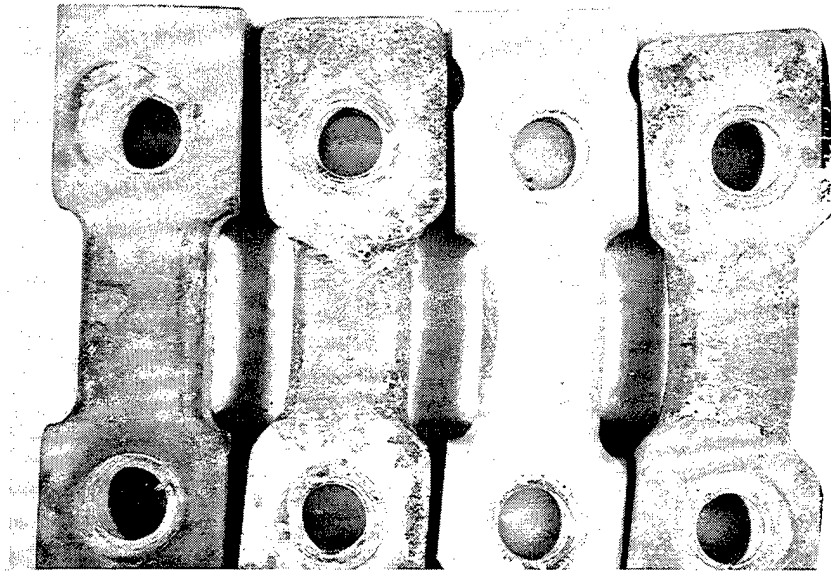
Figure 74. Top view of the lifting steel bar samples after their pull tests. The amounts of bend observed in three samples on the right were compared to the untested straight bar on the left. The first original bar (second from left) was pulled to 20,600 lbs maximum, the stronger bar made from T-1 steel material (third from left) to 39,500 lbs maximum, and the second original bar on right to 30,000 lb. Those three bars were permanently bent horizontally.

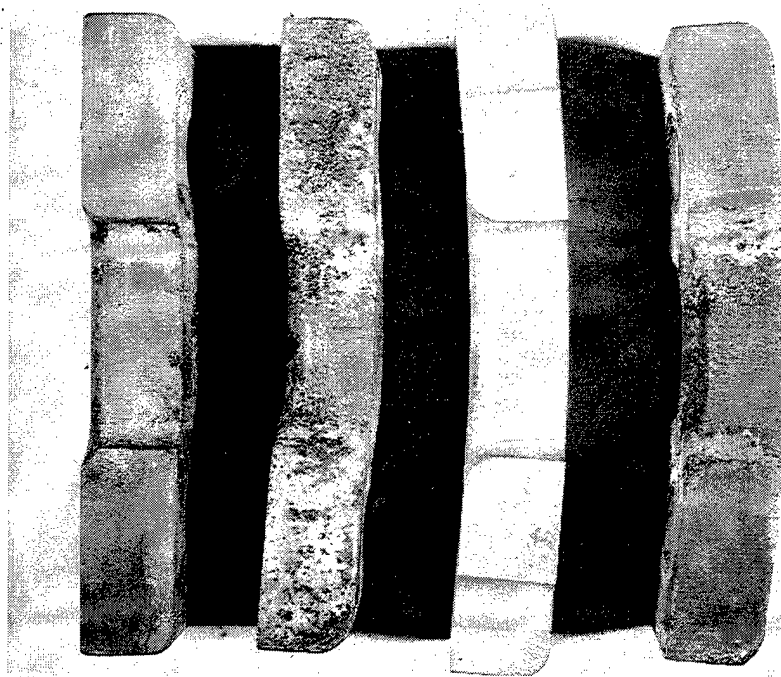
Figure 75. Side view of the same lifting steel bar samples in Figure 74. The three bars on the right were permanently bent vertically.

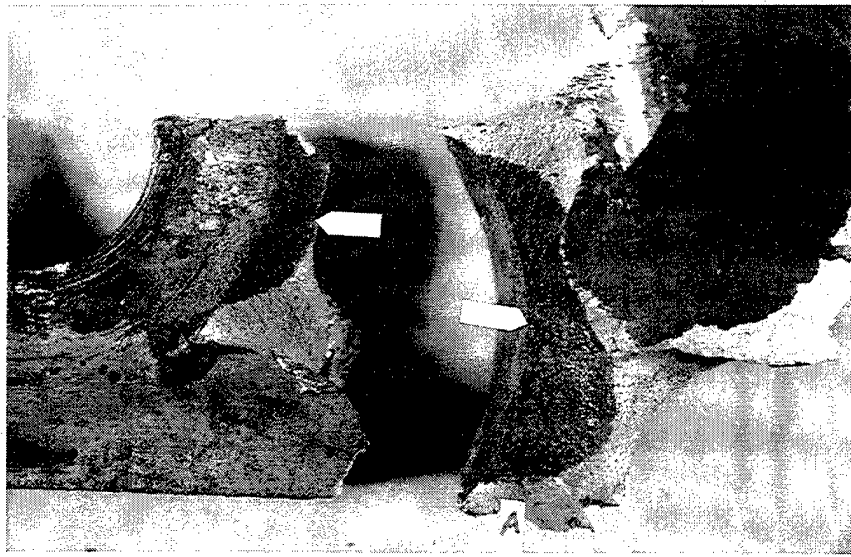
Figure 76. Two small aluminum pieces broken from a 1/2-inch-diameter bolt hole in the AVL B extruded deck panel containing the lifting device that was tested during the first pull test. The arrows point to the matching discolored (dark) areas in the fractured surfaces of both pieces. The curvature seen in the right piece (A) is the wall surface of the counterbore that cut into a protruded tread on the top surface of the deck panel to provide the clearance for the bolt head and socket tool. The pieces are seen in Figures 59 and 60. A small metallographic specimen was cut from the right piece for microstructural examination. Magnification: 2 1/4x.

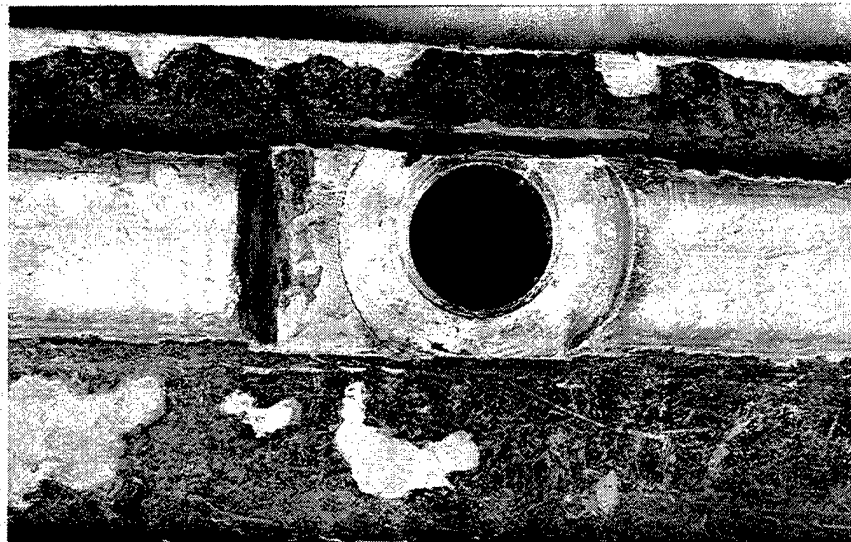
Figure 77. An example of a counterbored bolt hole made on top of the AVL B extruded aluminum deck panel. Note that counterboring had cut into the protruded tread on the right, leaving a sharp fillet at the bottom of the counterbored hole. The fillet can act as a stress raiser for the crack initiation.

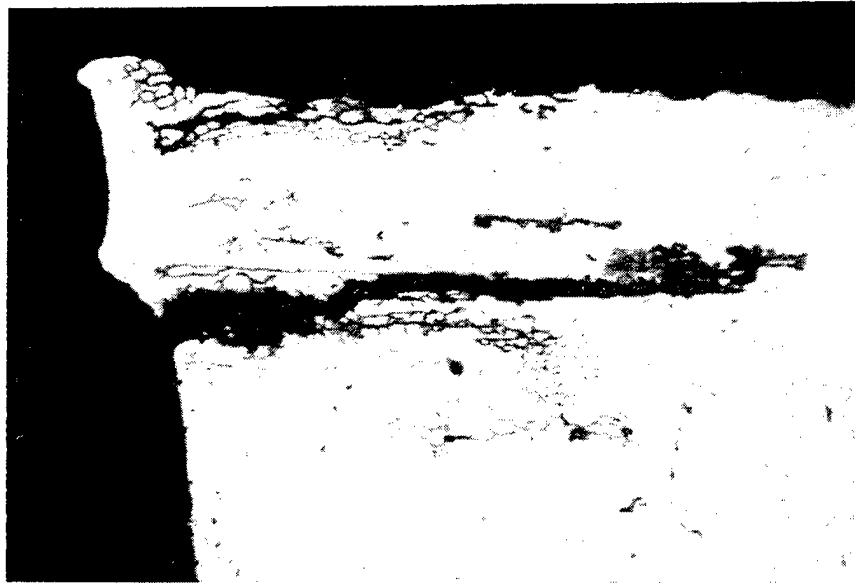
Figure 78. As-polished microstructure showing intergranular corrosion and cracks adjacent to the fracture at top. The vertical side on the left of the microstructure is the wall surface of the counterbore hole, and the slight curvature at the upper left is a portion of the sharp fillet at the bottom of the hole where a crack was initiated because the sharp fillet acted as a stress raiser. Magnification: 380x.

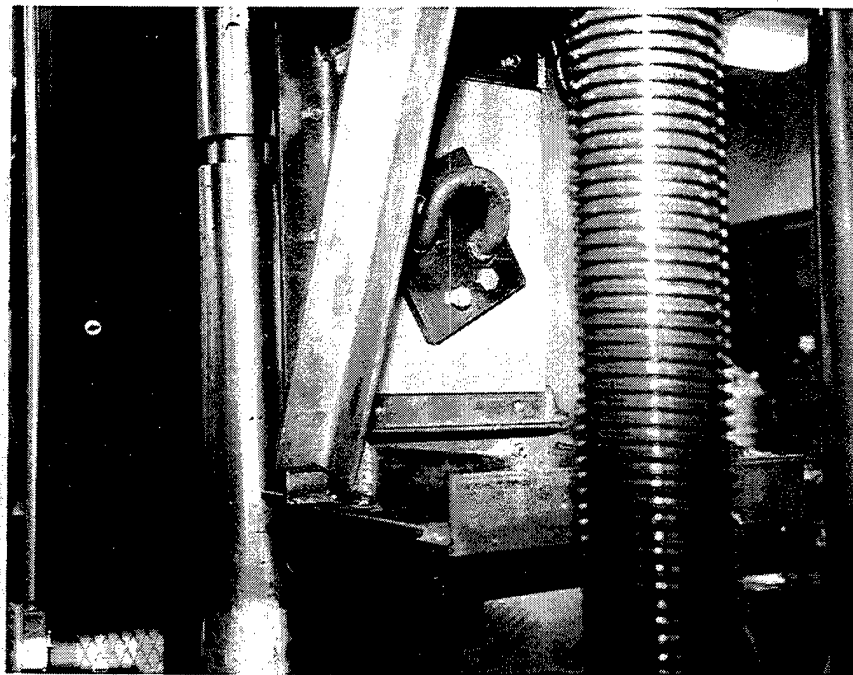
Figure 110. A view of the new lifting device after the perpendicular pull test. Note the extent of damage to the U-shaped bar on the device.

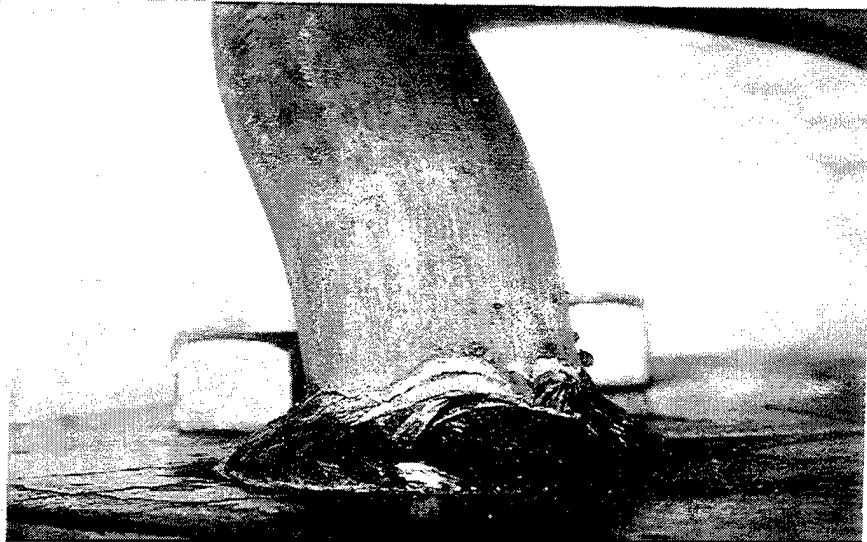
Figure 112. Closer view of the crack in the upper toe of the fillet weld in the damaged lifting device in Figure 111. Larger than actual size.
